Golden State Home Inspections

Inspection Report

Property Address:
1234 Main Street
Yourtown, Ca 95123

Date: 4/29/2008	Time: 04:00 PM	Report ID: 042908
Property: 1234 Main Street Yourtown, Ca 95123	Customer: Joe Homeowner	Real Estate Professional: Bob Agent

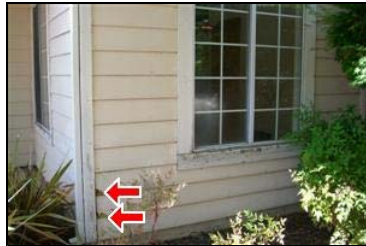
2.0 Picture 1

2.0 The Wood siding at the exterior deteriorated in various areas. Further deterioration can occur if not corrected. A qualified contractor should inspect and repair as needed I recommend prep and paint using a qualified contractor.

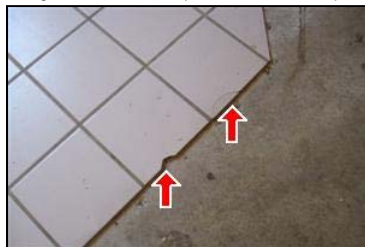
4.2 Picture 1

4.2 The vinyl and tile are cracked or damaged at the home. Repairs are needed. A qualified contractor should inspect and repair as needed. Other floor coverings are missing.

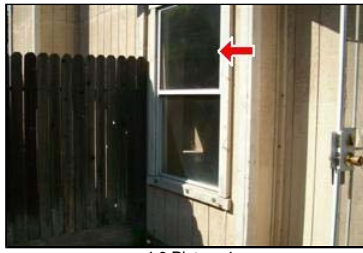
4.6 Picture 1

4.6 One window cloudy (lost seal) at the main entry. In order to correct the cloudy appearance of glass, a replacement of glass pane or the unit will be necessary. A qualified person should repair or replace as needed. Same window does not operate correctly. Recommend repairs.

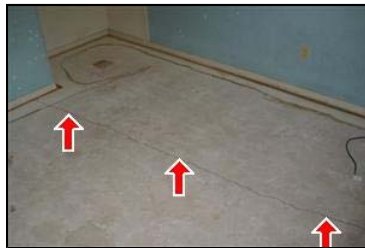
5.3 Picture 1

5.3 Excessive crack in slab does not appear to have current movement however, evaluation from a qualified engineer is recommended for a more conclusive prediction of future conditions.

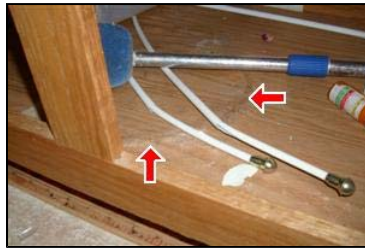
6.0 Picture 1

6.0 Not fully visible. Moisture damage under sinks. Slow drain at right master sink.

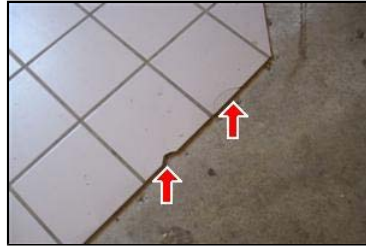
4.2 Picture 1

- ⬆ The vinyl and tile are cracked or damaged at the home. Repairs are needed. A qualified contractor should inspect and repair as needed. Other floor coverings are missing.

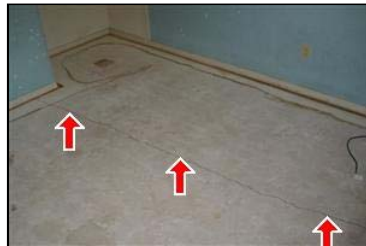
5.3 Picture 1

- Excessive crack in slab does not appear to have current movement however, evaluation from a qualified engineer is recommended for a more conclusive prediction of future conditions.

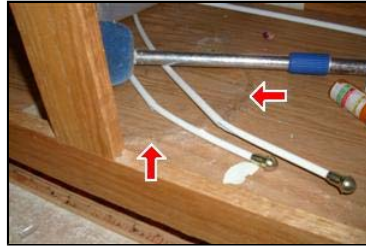
6.0 Picture 1

- Not fully visible. Moisture damage under sinks. Slow drain at right master sink.

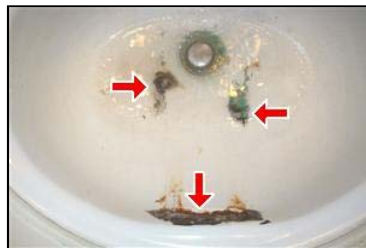
6.1 Picture 3

- Bathroom sinks are damaged or rusted in both bathrooms and kitchen. Shower head missing from master
